WASTEWATER COLLECTION AND TREATMENT IMPROVEMENT PROJECT

PROJECT REPORT

TEHAMA COUNTY SANITATION DISTRICT NO. 1 MINERAL

DECEMBER 2019

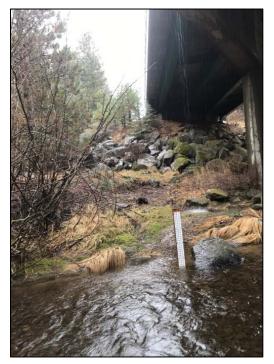
Photo 2 – USGS Staff Gage

Prior to 2018, SFBC flow measurements were based on the depth of flow above and below the top of the concrete ford immediately downstream of the point of discharge.

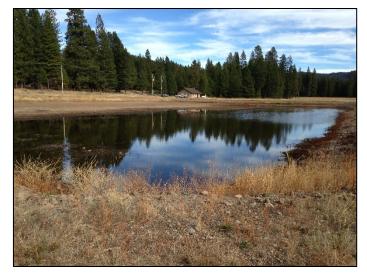
Photo 6 – Evaporation/Percolation Pond 1

Two 2.5-acre evaporation and percolation ponds are provided to receive effluent from the aeration basin. The ponds serve as settling basins for solids from the aeration process, as effluent disposal through evaporation and percolation, and as regulating storage for filtered discharge to SFBC. At least 2 feet of freeboard is maintained in both ponds at all times.

Pond 1 will overflow into Pond 2 at the 2-foot freeboard level. In recent years, the operations procedure has been to send effluent from the aeration basin into Pond 2, as it has a faster percolation rate than Pond 1. As Pond 2 begins to get full, effluent is diverted to Pond 1. Both ponds have been dried in the past, but the bottoms have never been cleaned. As indicated in the Sludge Disposal Plan, it is estimated that both ponds have less than six inches of sludge buildup based on the bottom readings of the pond staff gages over the years. The staff gages are scheduled to be surveyed by the County to ensure they are still calibrated accurately.

Percolation and Evaporation Ponds: The slopes down to the ponds get slippery, icy, and very wet in the winter months and make sampling a precarious task. As such, it is recommended that steps with railing be installed into Ponds 1 and 2 sooner rather than later for safety and sampling.

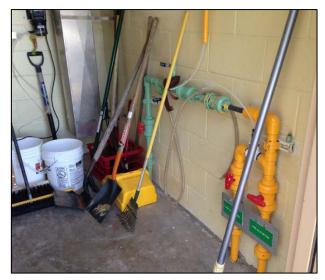
Photo 9 – Chlorination Piping

Chlorination equipment is installed in the Operations Building. All gas chlorine and sulfur dioxide equipment were removed in June 2013 in favor of liquid sodium hypochlorite and sodium bisulfite for safety reasons.

Chlorine injection points are located on filter influent piping for disinfection and to reduce excessive biological growth buildup inside the filter, as well as on the filter effluent standpipe in front of the chlorine contact pipeline for disinfection. The filter effluent is normally chlorinated at the filter standpipe just prior to being discharged to the 420-foot-long, 27-inch chlorine contact pipeline. Approximately 30 minutes of contact time is provided at 400 GPM to

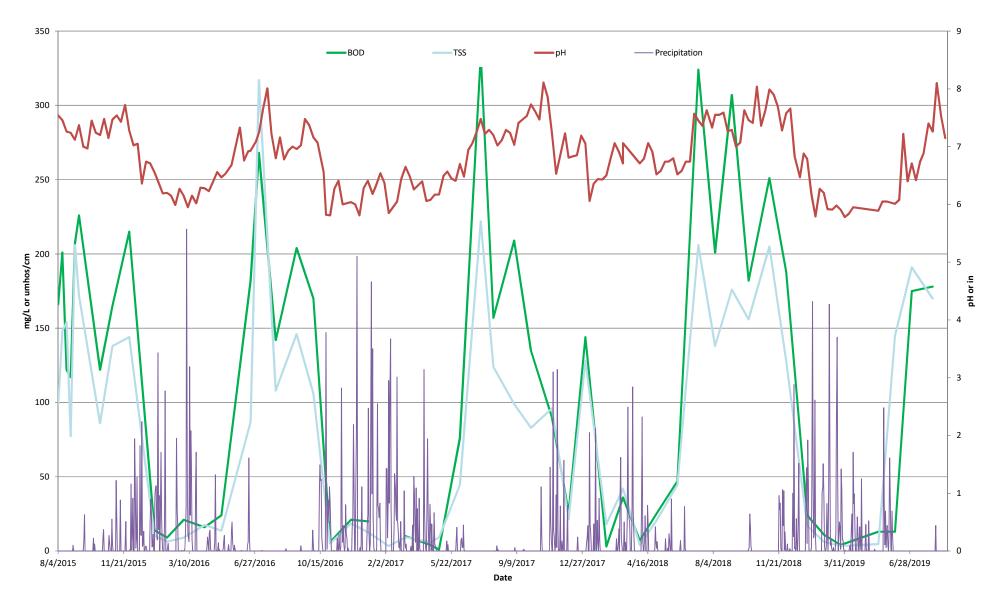
FIGURE 3 Tehama County Sanitation District No. 1 Mineral Wastewater Collection and Treatment Improvement Project Influent Wastewater Characteristics
